Removing 2018 Winnebago 2108DS Furnace to Clean the Sail Switch

The model number on the furnace housing is AFSD20121

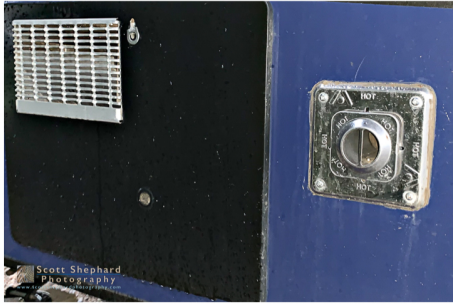
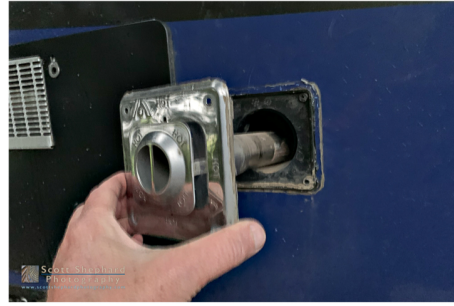
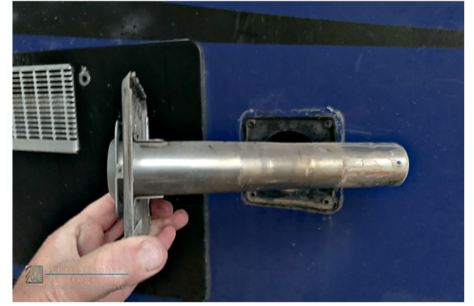
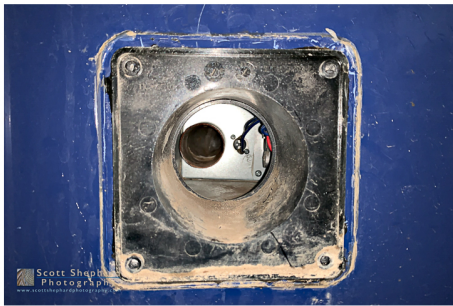
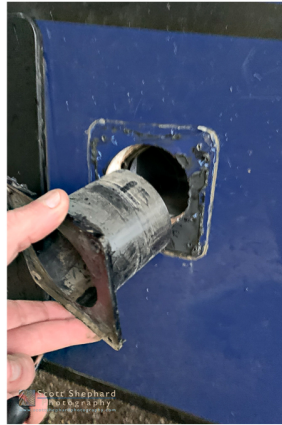
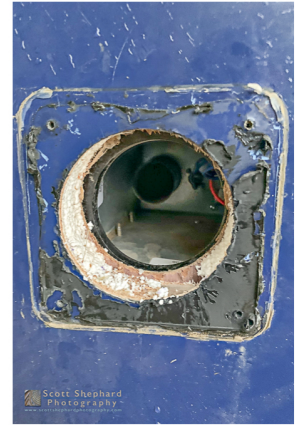
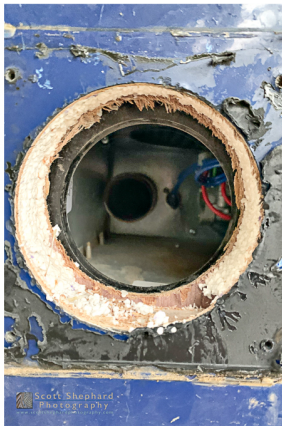
Step 3: Remove Outside Furnace Exhaust Fittings (Photos 1-7)

On the outside of the trailer remove the metal exhaust vent by removing the four square drive self tapping screws. The exhaust pipe is curved and will only fit back in one way. You might want to mark the top of the square exterior exhaust vent so you can easily put this back in at the end of the process. Then remove the rubber piece under the metal vent. This is held in with caulking and needs to be taken off as the end of fits in to the back of the furnace by friction. I used a flexible putty knife to remove this piece.

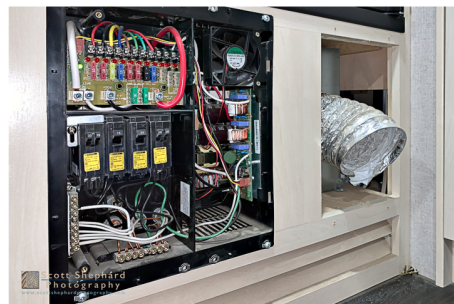
Photo 8

Inside the camper remove the facing of the electrical panel and remove the plastic furnace grill next to it. (8) The primary flexible ducting fits onto the back of the furnace grill by friction. (9) Then remove the flexible ducting from the furnace body by turning the hose until the the small

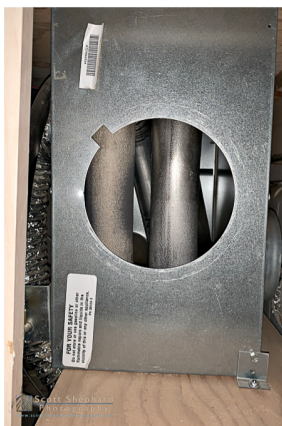
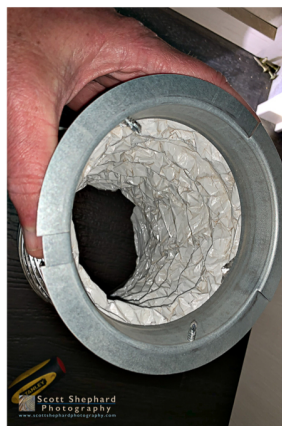
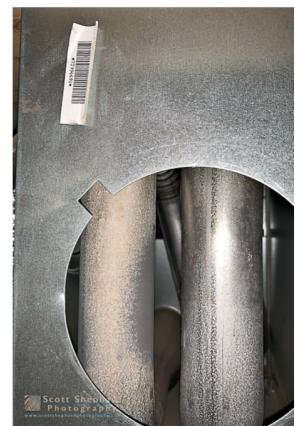
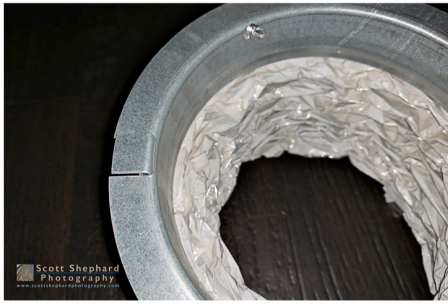
flange on the back of the fitting lines up with the slot on the furnace body. (10-13) Disconnect the smaller bathroom flexible ducting from the right side of the furnace body by first loosening the hose clamp. After pulling the hose off, remove the metal flange from the furnace body by rotating until the slots line up. (14-17) (You may be able to remove the ducting by rotating the flange without loosening the hose clamp. In my case there didn't seem to be enough play for this and I didn't want to damage the ducting.)

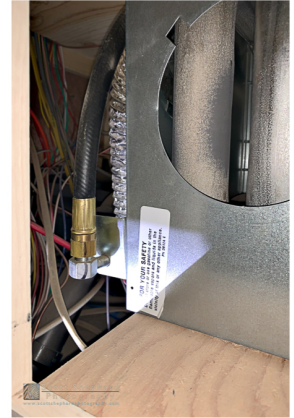
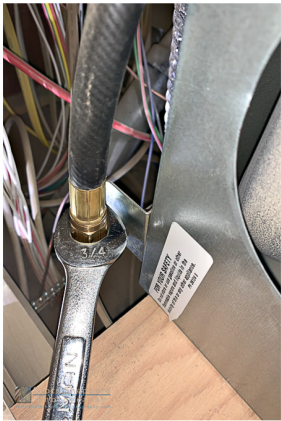
Step 5: Disconnect Gas Line (Photos 18 & 19)

The gas line is the black hose connected at the bottom left of the furnace front. It takes a 3/4" open ended wrench to do so.

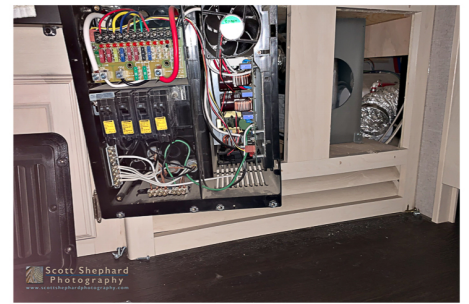
Photo 21

To do this you will probably have to remove the 4 screws that hold the electrical distribution/fuse box in place and then gently pull it out to create a gap. (21) There is some play in the wires leading to the electrical box but BE CAREFUL not to pull too hard. This flexible ducting is held on by the same kind of slotted flange that the main and bathroom hot air ducting is. Just rotate to remove. (22 & 23)

- 4) The cause of the problem? Because it doesn't take much to clog a sail switch, it is possible that pet hair and other fibers may have made their way into the furnace. The air intake for the furnace is the louvered panel just below the access to the furnace and the electrical cabinet. (See photo 21) It is possible that some kind of filter in this area could help solve the problem BUT given that the amount and speed of air flow over the "sail" of the sail switch is what triggers the ignition mechanism, too much filtering could render the furnace inoperable. It's time for some experimentation

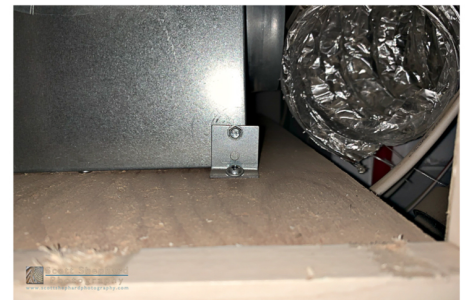
Photo 24

There is bracket on the bottom right front of the furnace and only 1 screw holding the furnace in place. (24) (The black plastic flange you removed from the outside of the trailer is what secures the back of the furnace and it does so by friction. (4 & 5)) Remove this screw, which requires a square drive bit. Remove the bracket from the front of the furnace box using a 1/4" socket. (25 & 26) IMPORTANT: In my 2108DS the furnace is a very tight fit and you will likely need to gouge the cabinet facing to remove the furnace. (27 & 28) If you feel resistance, it is likely either a screw on the top of the furnace or on the bottom contacting the cabinet facing. (29-31) I used a Dremmel tool to make a shallow slot to make removal easier. This gouging, incidentally, is covered by the furnace grill.

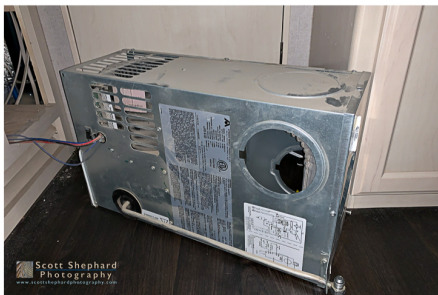
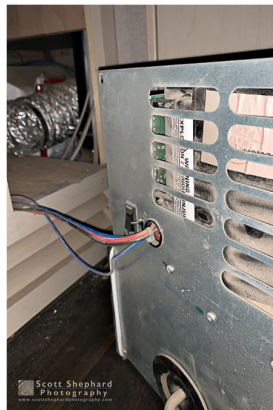
The furnace is wired at the back (34 & 35) but there is enough wire to allow it to be take out of the cabinet without cutting or disconnecting wires. BE GENTLE and DELIBERATE in doing this so you don't do damage to the wiring.

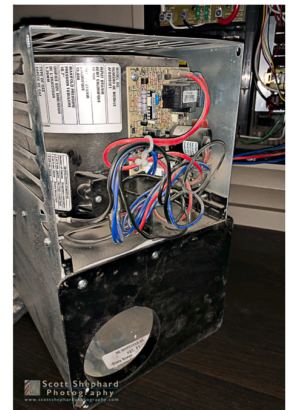
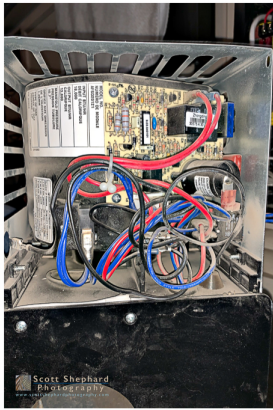
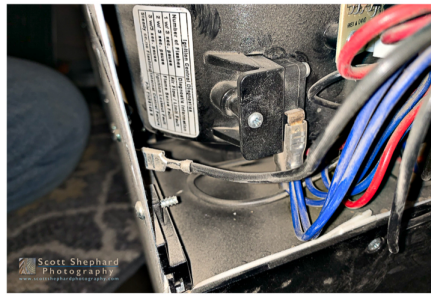
Step 8: Remove Sail Switch (36-40)

As you look at the back of the furnace, the circuit board is at the top and the sail switch is towards the bottom left. It is wired with two blue wires. Remove both wires by siding them off of the sail switch terminals. Before removing MARK at least 1 wire and its corresponding terminal so you can get them back in their original locations. The sail switch is held in by one screw. Once you have removed the screw, you should be able to pull the sail switch mechanism out. BE VERY CAREFUL DOING THIS AS THE SAIL SWITCH APPEARS TO BE A FAIRLY DELICATE.

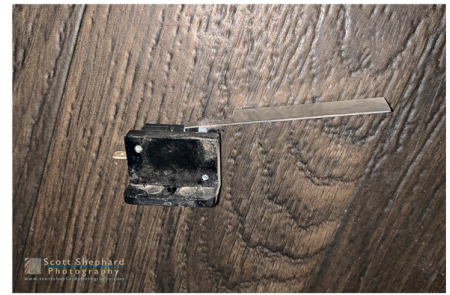
Photo 39

You have to look closely at second to last photo (39) to see what was causing my furnace to fail to ignite: it was a small clump of fuzz. The last photo (40) shows a clean switch and the culprit below it. It is conceivable that you have a faulty sail switch, in which case you need to install a new one. They are cheap and readily available and it might be a good idea to have a backup.
